What is condition assessment?

"The process used to describe the condition and/or performance of a system component."

Condition Assessment Program Cycle

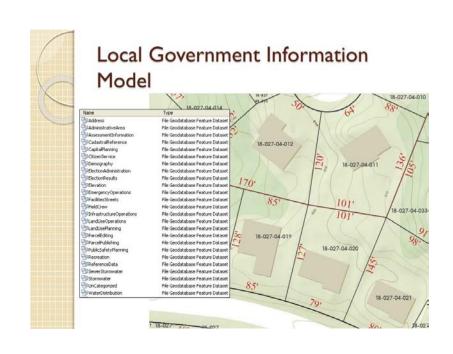
Database Design

- Local Government Information Model (LGIM)
 - ESRI's preferred data model
 - Scalable
 - Preconfigured domains and feature classes
 - Modify as needed

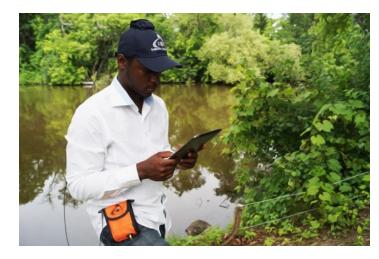
- External GPS
 - Submeter accuracy
 - Bluetooth to tablet
 - ~\$3,000 per unit

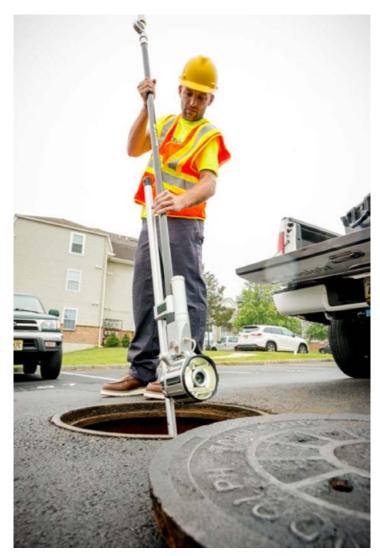
Inspection technology

- Zoom cameras
 - Supplements surface inventory
 - Provides shots of pipes from structure
 - Photos limited to straight-line pipe
 - Helps lower overall project cost by reducing CCTV scope

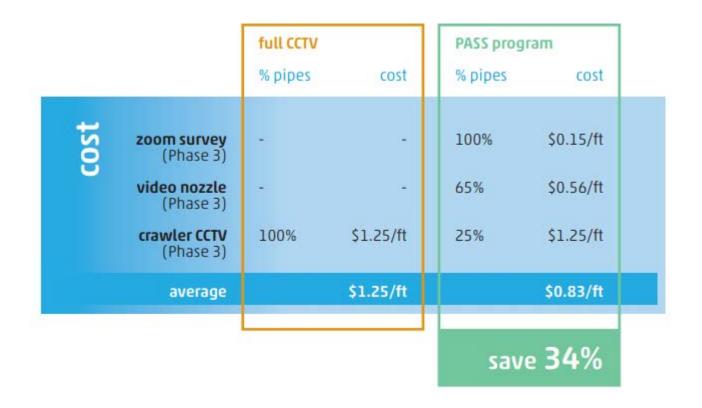
Inspection technology

- Zoom cameras
 - Phased Assessment Strategy for Sewers (PASS)

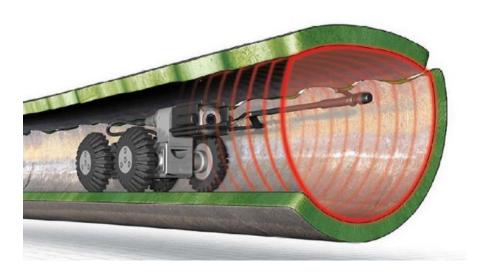
Inspection technology

- CCTV
 - Pipe inspections
 - Reports and videos
 - Can be linked to GIS and ratings symbolized on map
 - ~\$1.50 LF
 - Heavy cleaning expressed as an hourly rate

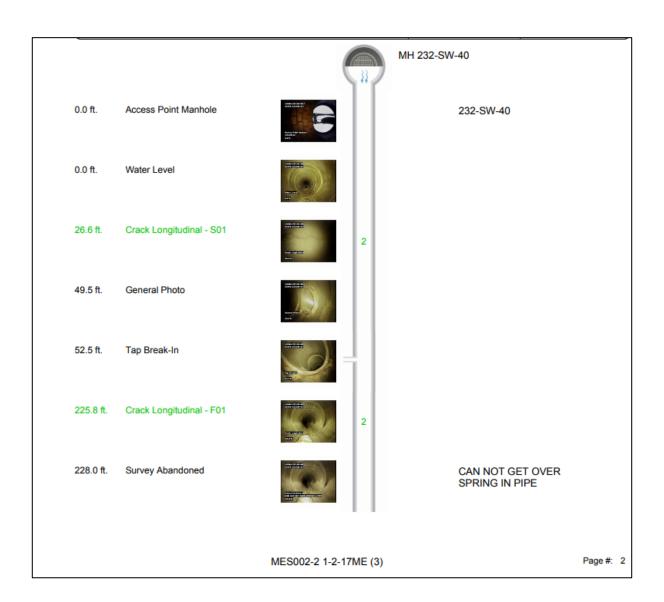
Inspection technology

Pipe Segm	ent Refere	С	ity	Street	Material		Location C	Sewer Use
Line 23	2-SW-174	Tulsa	a, OK	E 17TH PL	Reinforced Concrete		Light High	Stormwater
Upstre	am MH	Total I	Length	Year Laid	Sh	аре	Location	n Details
MH 23	2-SW-40	3	52		Circ	ular		
DS N	anhole	Length s	surveyed	Year Renewed	Height	Width	Pipe Joint	
MH 232	-SW-107	22	28		30	30 30		oxdot
SPR	80	MPR	N/A	PO Number			Customer	
SPRI	2	MPRI	N/A	1	Mes		shek & Associates	
SPRI		IVIPRI	N/A	Work Order			Purpose	
QSR	2G00	QMR	N/A		Mai		aintenance Related	
C	PR	Surve	yed By	Direction	Date		Media label	
	30	ACE	/MEJ	Downstream	20180122			
0	PRI	Certificati	e Number	Pre-Cleaning	ning Time		Weather	
	2 U-0218-070300598 No Pre-Cleaning 14:38		:38 Very Dry					
	Date Cleaned		leaned		End Time		Additional Info	
					14	:56

Structural Ratings			0	& M Ratin	gs	Con	bined Ra	tings
Normal Defects		Grade Rating	No. Occur.	Rating	Grade Rating	No. Occur.	Rating	Grade Rating	No. Occur.	Rating	
			1	0	0	1	0	0	1	0	0
			2	0	0	2	0	0	2	0	0
			3	0	0	3	0	0	3	0	0
			4	0	0	4	0	0	4	0	0
			5	0	0	5	0	0	5	0	0
Contin	Continuous Defects Code ID Length										
			1	40	00		_		2	40	00
CL	F01	199.2	2	40	80	0	0	0	2	40	80
			Subtotals	40		Subtotals	0		Subtotals	40	
SI	UMMA	PV	Pi	pe Rating	80	Pi	pe Rating	0	Overall P	pe Rating	80
	C.MINA		Struct	ural Index	2.0	0	&M Index	0	Ove	erall Index	2.0
			Str. Qu	ick Rating	2G00	O&M Qu	ick Rating	0000	Ovrl. Qu	ick Rating	2G00

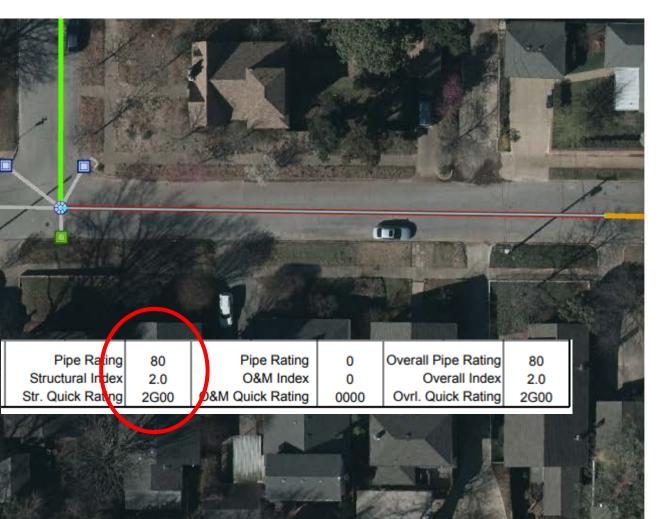
Inspection technology

Material UNK Pipe Width 30 Pipe Height 30 Inspection Date 1/21/2018 Start Time 1/22/2018, 8:38 AM End Time 1/22/2018, 8:56 AM Operator ACE/MEJ Certificate Number U-0218-070300598 Very Dry Weather No Pre-Cleaning Cleaned Flow Control Inspection Direction Downstream Inspection Length 228.0 Quick Structural Rating 2G00 Quick O&M Rating 0000 Quick Overall Rating 2G00 Structural Pipe Rating 80 O&M Pipe Rating 0 Overall Pipe Rating 80 Structural Pipe Rating Index 2.00 0.00 O&M Pipe Rating Index 2.00 Overall Pipe Rating Index Hyperlink (Report) More info Hyperlink (Video) More info

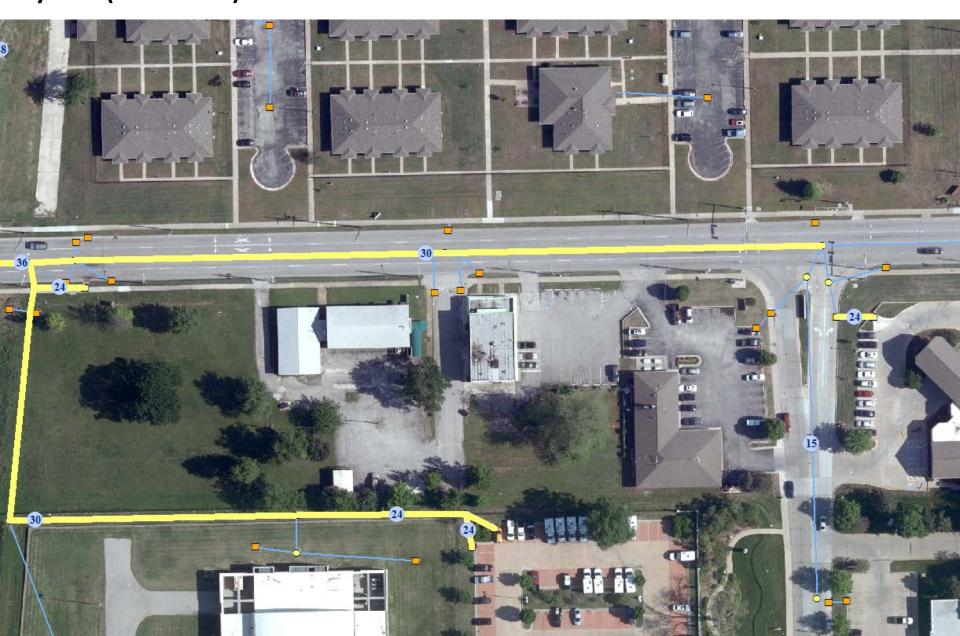
By Size (18" to 54")

- By Size
 - 18" 54"
- By area
 - Entire systems, regardless of size
- By criticality
 - Major roads
 - Critical facilities

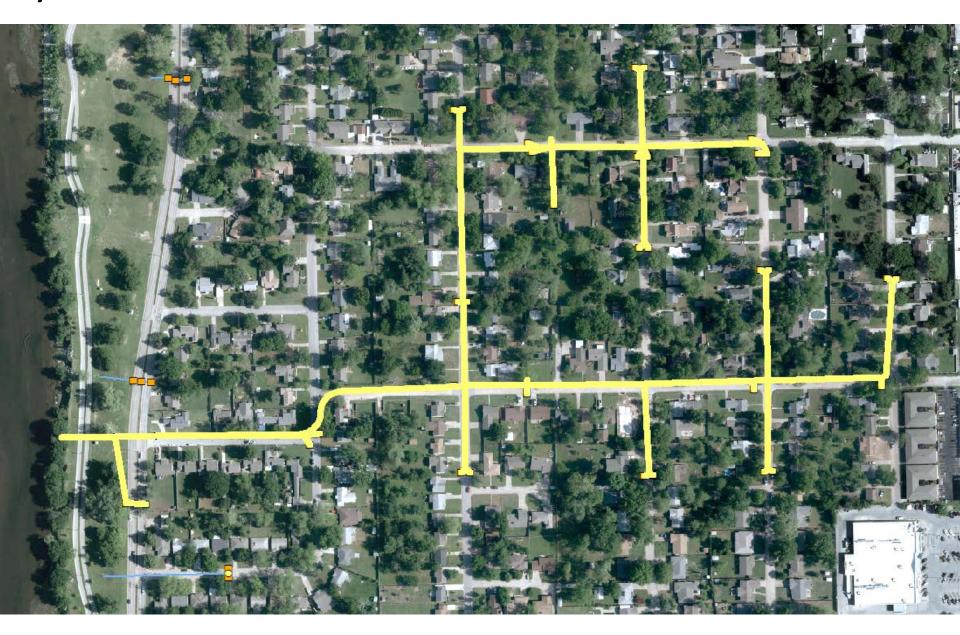
By Area

- By Size
 - 18" 54"
- By area
 - Entire systems, regardless of size
- By criticality
 - Major roads
 - Critical facilities

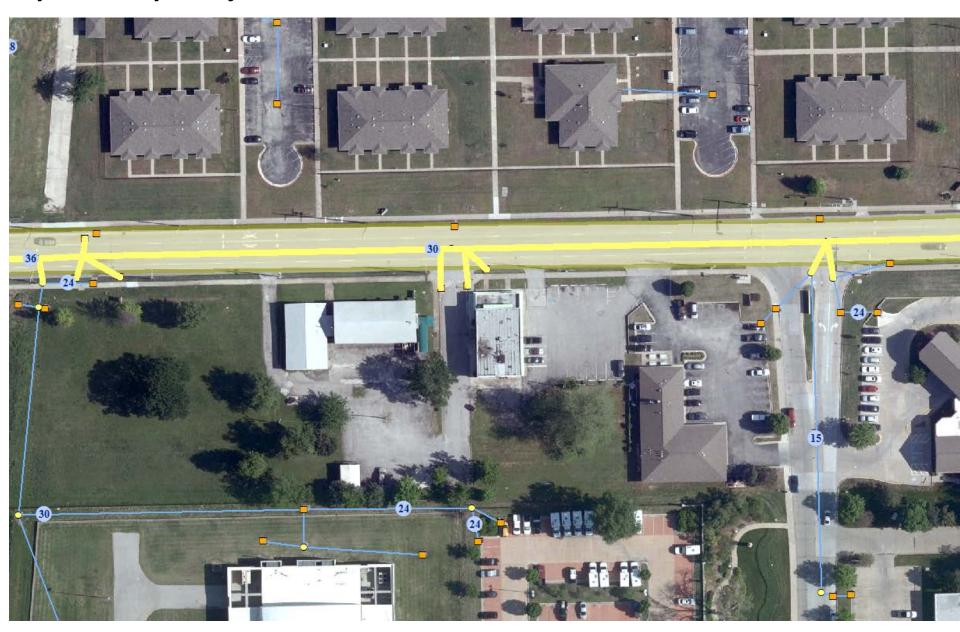
By Criticality – Major Roads

- By Size
 - 18" 54"
- By area
 - Entire systems, regardless of size
- By criticality
 - Major roads
 - Critical facilities

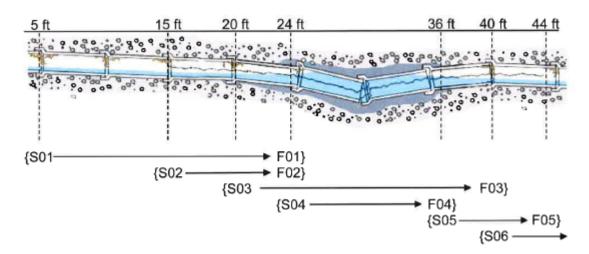
Point and Continuous Defects

- Point defect a discrete defect < 3 feet in length
- Continuous defect
 - Truly continuous 3 feet or longer
 - A crack running longitudinally along the pipe at the 12 o'clock for 42 feet
 - Repeat continuous at 3 of every 4 joints
 - Infiltration Weeper at every pipe joint for 70 feet
- Continuous defects are noted as 2 separate entries with respective "Start" and "End" labels, along with the stationing

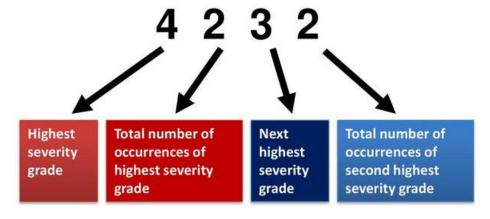
Rating System

Quick Rating

Overall Rating – sum of all grades

Occurrences			Segment Grade Scores		
Grade	Structural	O&M	Overall	Structural	O&M	Overall
1	1	3	4	1	3	4
2	3	5	8	6	10	16
3	2	4	6	6	12	18
4	5	0	5	20	0	20
5	3	2	5	15	10	25
	14	14	28	48	35	83

Rating Index – Overall Rating divided by number of defects

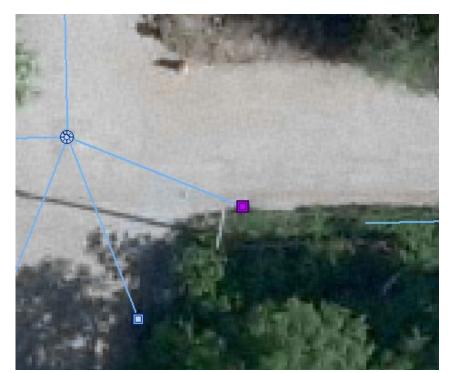
Surface Ratings

- Defect scores summarized separately for each structure
 - Structural rating
 - O&M rating
 - Combined rating

Field	Value
GEN_MACP_CODE	Cracks & Fractures
COMPONENT	Wall Interior
MACP_CODE	Fracture Multiple
CONTINUOUS	Yes
VALUE_1ST_DIMENSION	4.5
VALUE_2ND_DIMENSION	<null></null>
VALUE_PERCENT	No Rating
EPD	4.5
GRADE_CAT	Structural
COND_GRADE	4
STRUCTURAL_GRADE	18
OM_GRADE	0

Doloot 2		
Field	Value	
GEN_MACP_CODE	Debris & Obstructions	
COMPONENT	Bench/Floor	
MACP_CODE	Deposits Settled Fine	
CONTINUOUS	No	
VALUE_1ST_DIMENSION	<null></null>	
VALUE_2ND_DIMENSION	<null></null>	
VALUE_PERCENT	51-75%	
EPD	1	
GRADE_CAT	O&M	
COND_GRADE	3	
STRUCTURAL_GRADE	0	
OM_GRADE	3

Field	Value
INLETTYPE	Curb Inlet
OMR_STRUCTURAL	18
OMR_OM	3
OMR_COMBINED	21
MRI_STRUCTURAL	4
MRI_OM	3
MRI_COMBINED	3.818182
QOR	4131

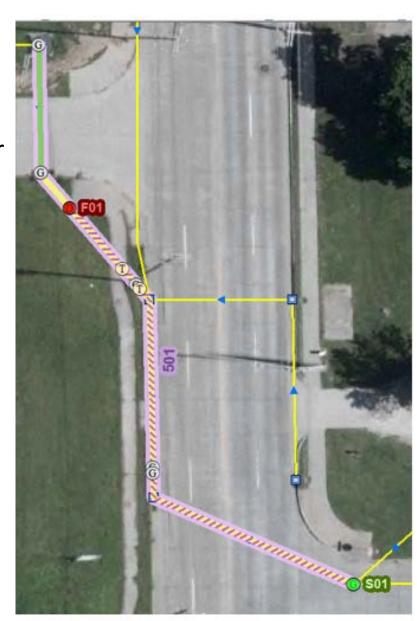
Subsurface Ratings

- Using linear referencing ...
 - Point defects plotted as **point** features
 - Continuous defects plotted as **line** features
- Defect scores summarized separately for each segment
 - Structural rating
 - O&M rating
 - Combined rating
- Provides **segment** rating

Field	Value
INSPECTION_ID	501
SURVEY_DIRECTION	Upstream
EPD_STRUCTURAL	0
EPD_OM	13.700187
EPD_COMBINED	13.700187
OPR_STRUCTURAL	0
OPR_OM	27
OPR_COMBINED	27
PRI_STRUCTURAL	0
PRI_OM	1.970776
PRI_COMBINED	1.970776
QOR_STRUCTURAL	0000
QOR_OM	2A00
QOR_COMBINED	2A00

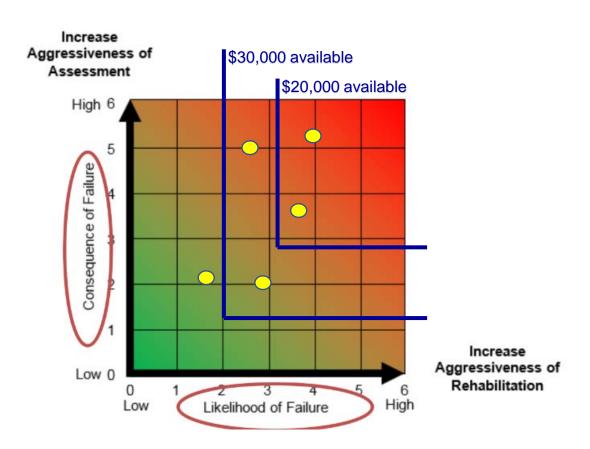
Risk Assessment

- Likelihood of Failure (LOF) Determined by condition scores
- Consequence of Failure (COF) Determined by asset owner
- Risk = LOF x COF
